**U.S. Environmental Protection Agency
OPA90 Removal Project Plan**

Date: August 29, 2012
From: Thomas Condon, On-Scene Coordinator
U.S. EPA, Region 1
To: LCDR Freddie Thompson, U.S. Coast Guard
National Pollution Funds Center
Subject: Oil Removal Project Plan
Lonsdale Bleachery Site
Lincoln, Rhode Island

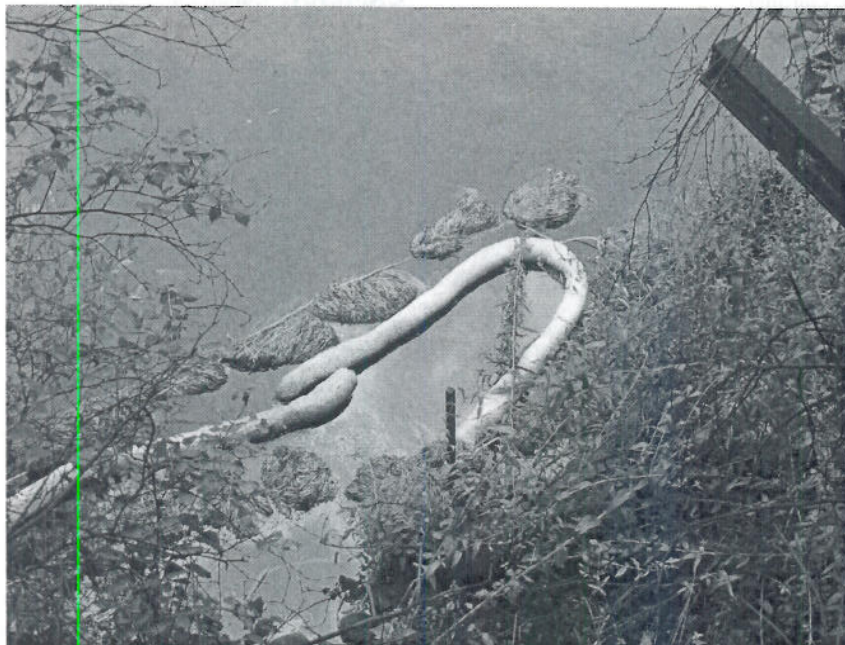
SCENE: Sheen on Blackstone River emanating from Site. Photograph taken facing northeast.

Due to the location and nature of the contamination described herein, this ongoing release poses an imminent threat of continued discharge of oil into navigable waterways of the United States. Oil globules can be observed seeping out from the base of the granite retaining wall (particularly during periods of low water) and creating a sheen on the Blackstone River.

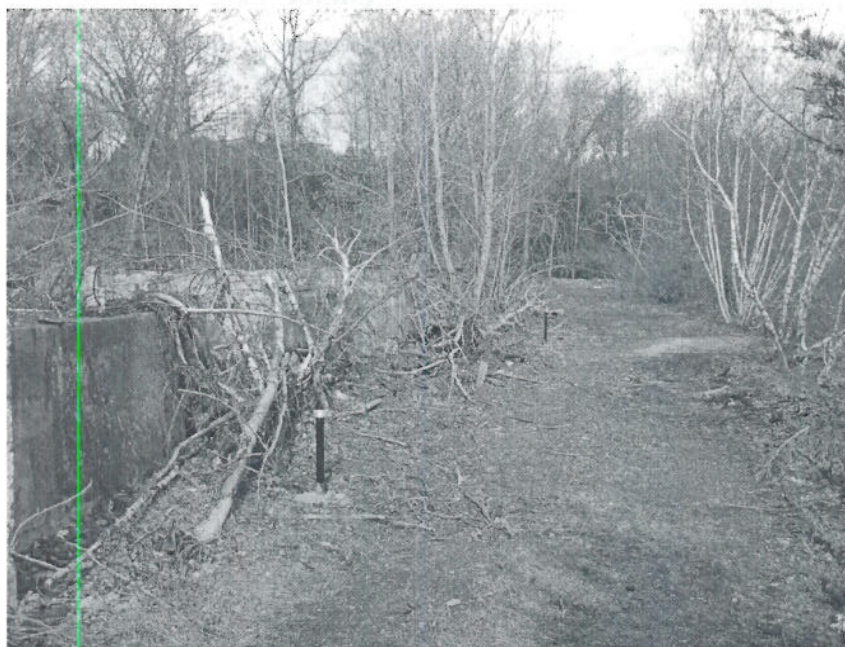
SCENE: View of Site prior to cleanup activities. Photograph taken facing west. Concrete structure on the left is the remnants of the former "coal shed". The oil storage bunkers were later encountered below grade, beneath the coal shed.

Beneath the ruins of the former coal shed structure, three underground, concrete fuel oil storage bunkers and associated piping were uncovered and cleaned out. The bunkers were demolished to permit access to the underlying oil-saturated soils and floating product. Approximately 5000-10,000 tons of these oil-saturated soils are estimated to be present, extending as much 10 feet below the former bunkers (20 feet below original grade). Due to these site conditions and the immediate proximity of both the river and an elevated canal/raceway, approximately 500 linear feet of sheet piling was installed during the fall of 2006 to allow for safe excavation activities. EPA and the ERRS contractor are currently excavating the oil-saturated soils and shipping them off-site for disposal via asphalt batching. Within the sheet-piled excavation area, the water table is being depressed with a dewatering system to permit the safe excavation of the oil-saturated soils. Free oil is being collected from the water surface with a drum skimmer, and oily water is being treated in an on-site water treatment system.

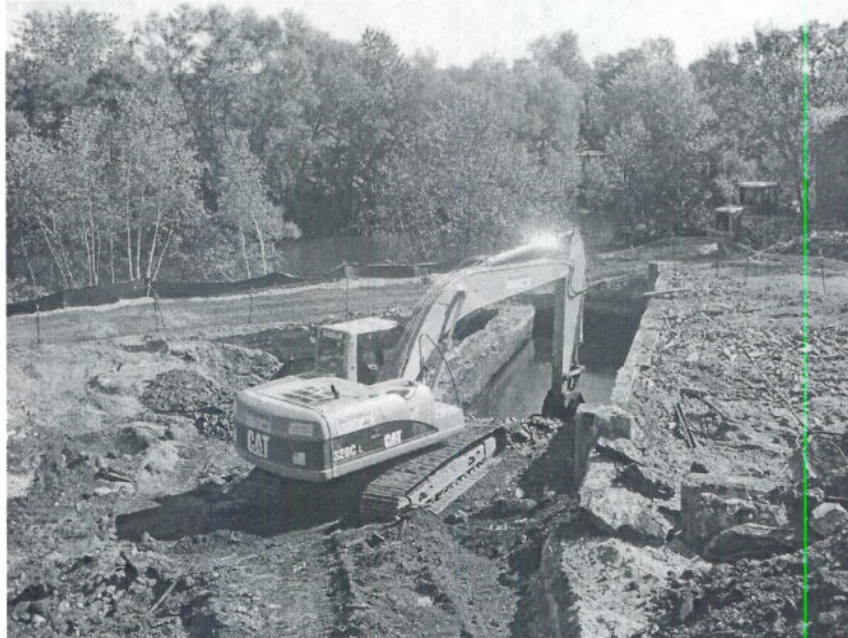
SCENE: View of excavation of oil-contaminated soils from former oil storage bunker area. Photograph taken facing northeast. Note proximity of Blackstone River in background.

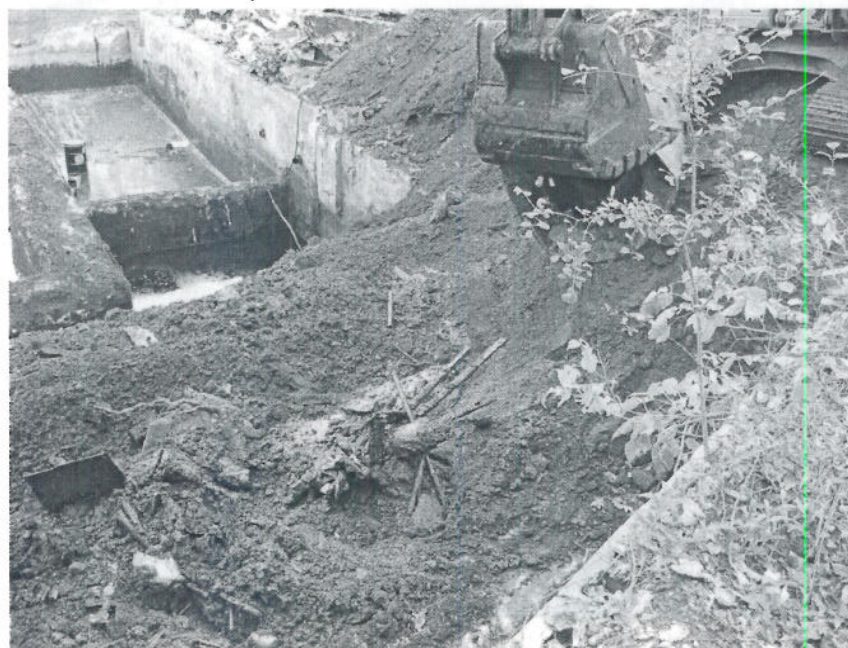
SCENE: View of excavation of oil-contaminated soils and debris from former oil storage bunker area. Photograph taken facing east.

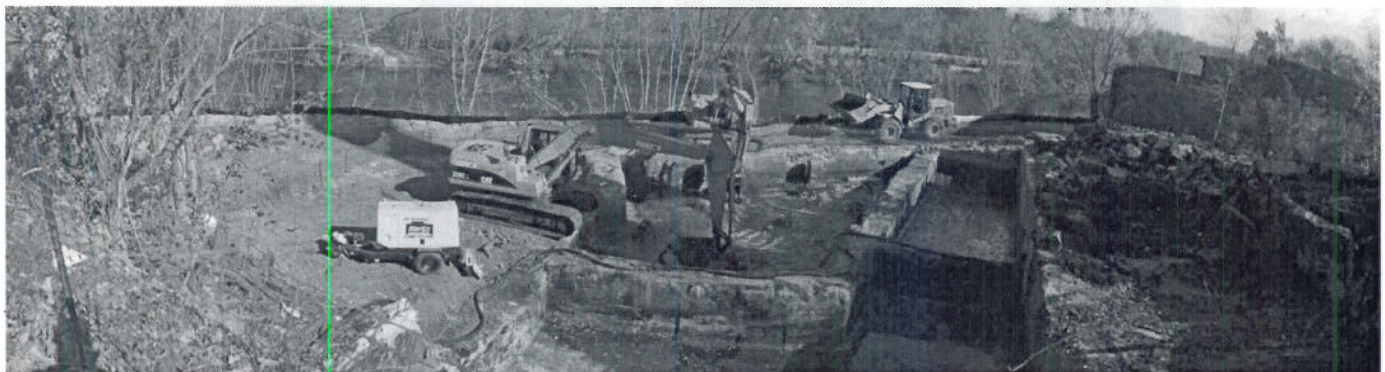
SCENE: Panorama of Site after bunkers were cleaned out. Photograph taken facing northeast.

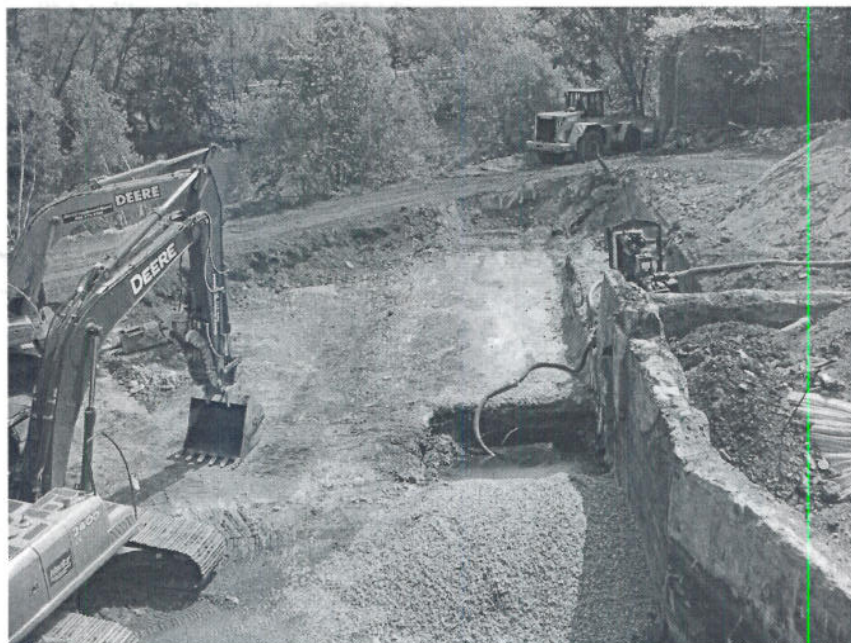
SCENE: View of bunker demolition activities. Note heavy amount of oil encountered beneath floor of bunker. Photograph taken facing northeast.

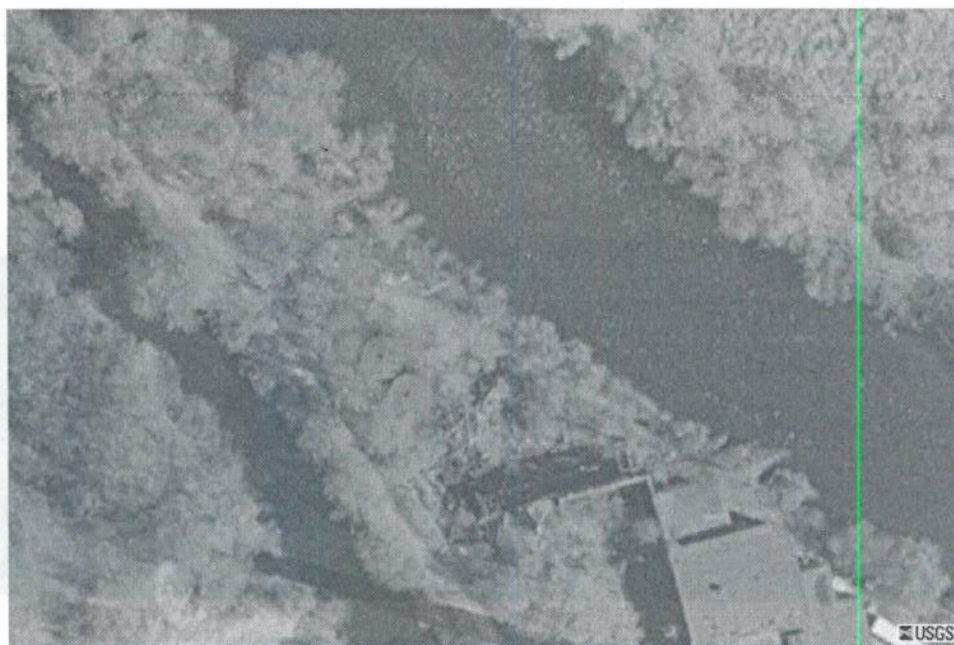
SCENE: Aerial photo of site and surrounding area. Note river to north and east of site and canal/raceway to the south and west.

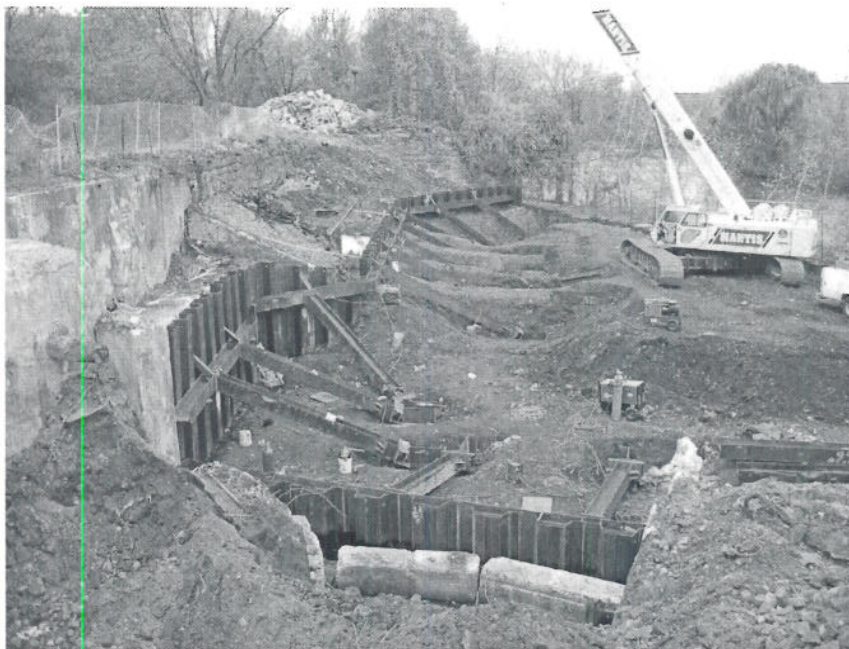
SCENE: View of sheet piling installation activities. Photograph taken facing west.

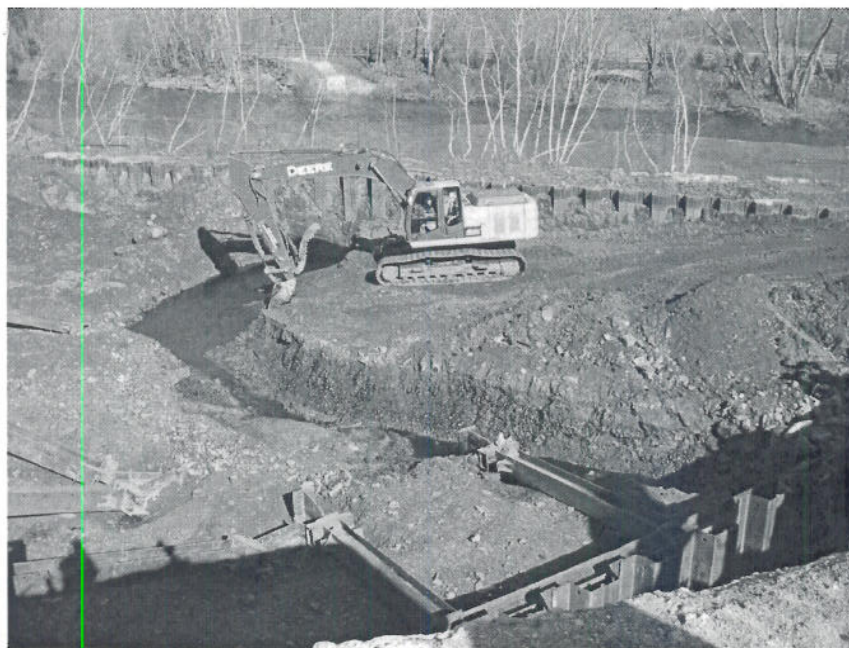
SCENE: Excavation of oil-saturated soils. Photograph taken facing north.
